Product Change Notice

(PCN Tracking Number: EE-QR-220301-01)

Customer:	ALL Customers
Renesas Product Type:	RA2E2 Group (Refer to Product list on last page)
Description of Change:	<p>The applicable products (MCU Ver.1) listed in the Product List have restrictions and precautions on the I²C / I3C bus interface. Regarding the restrictions and precautions of MCU Ver.1, the workarounds and precautions have already been described in RA2E2 Group User's Manual Hardware Rev.1.00 (R01UH0919EJ0100). However, in order to improve the function of the I²C / I3C bus interface, the products were revised and the MCU version was changed from MCU Ver.1 to MCU Ver.2. For details of the changes, please refer to pages 4-17. The software workarounds of MCU Ver.1 can be executed on MCU Ver.2 without any changes.</p>
Reason for Change:	Improved I ² C / I3C bus interface function
Identification:	Change of the last digit of the booking part numbers from 0 to 1 in comparison between MCU Ver.1 and MCU Ver.2 (refer to page 3)

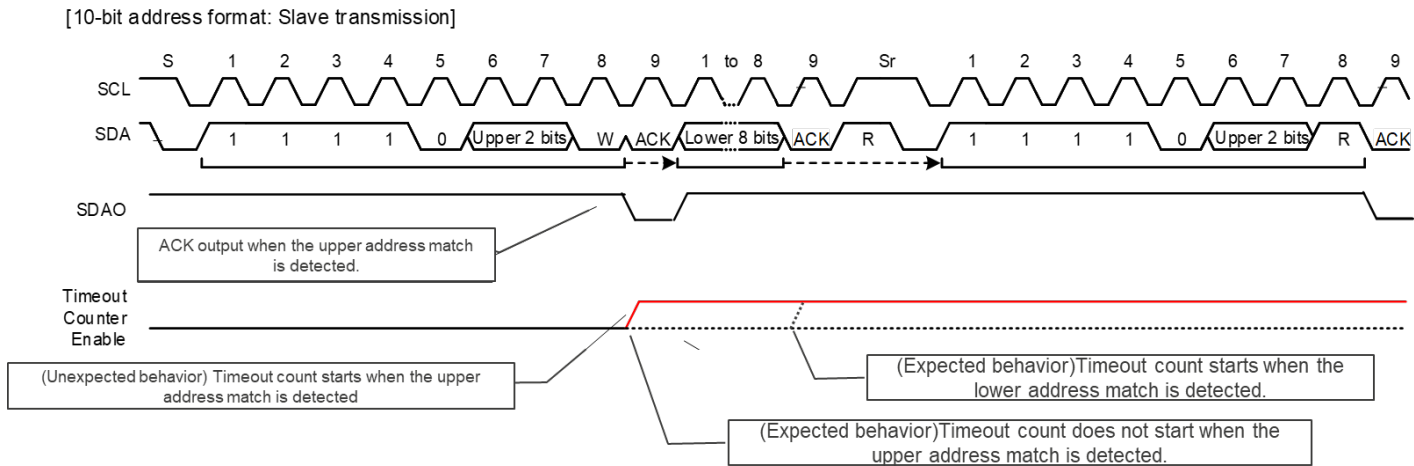
#2 : I²C slave; Timeout count operation when 10-bit address communication and the upper address match is detected

In MCU Ver.1, the timeout count starts when 10-bit address communication and the upper address match is detected.

MCU Ver.2 is revised the circuit so that the timeout count does not start until the lower address match is detected after the upper address match is detected.

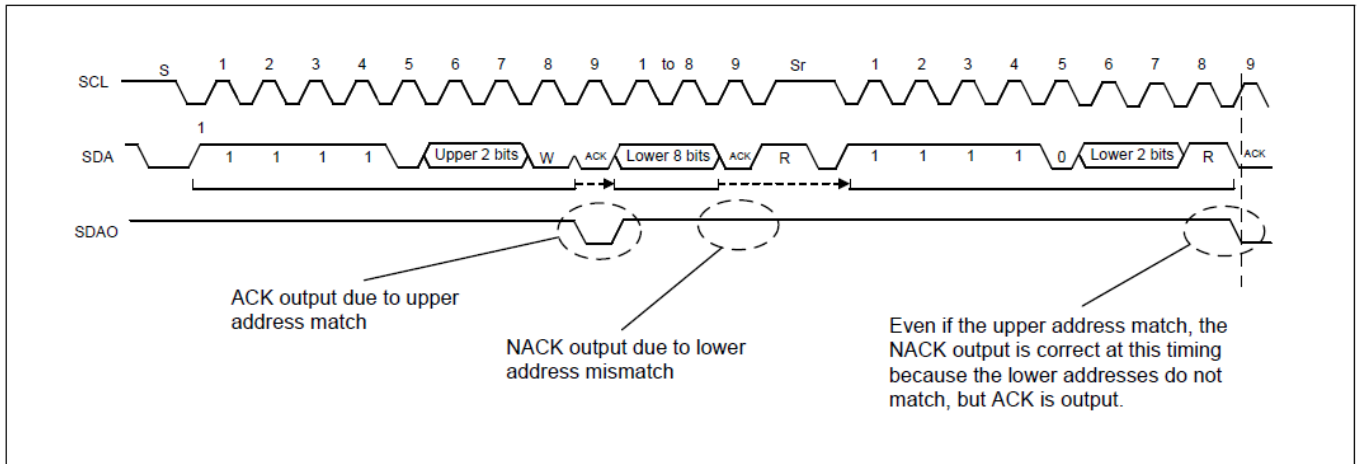
#3 : I²C slave; ACK output operation when 10-bit address communication and the lower address mismatch is detected

MCU Ver.1 has the following restrictions and workarounds when using 10-bit address communication. The restrictions and workarounds are not required for MCU Ver.2

When multiple I²C slaves are connected to the I²C bus and there is a possibility that an I²C Slave other than this module will NACK for the upper address / R after Repeated START, there are the following restrictions and workarounds.

- Work around : Set the upper 2 bits of the 10-bit address assigned to this module to a value different from other Slave. If the address is exhausted and cannot be set to a different value, use restriction (1).
- Restriction (1) : 10-bit address not available.
- Restriction (2) : After the ACK response in the red circle in the above figure, none of the slaves respond to data, so the SDA keeps the high level and the I²C Master receives the 0xFF data. In the case of a system that can handle 0xFF as abnormal data, 0xFF is read and discarded on the I²C Master side. If 0xFF is valid data, use restriction (1).

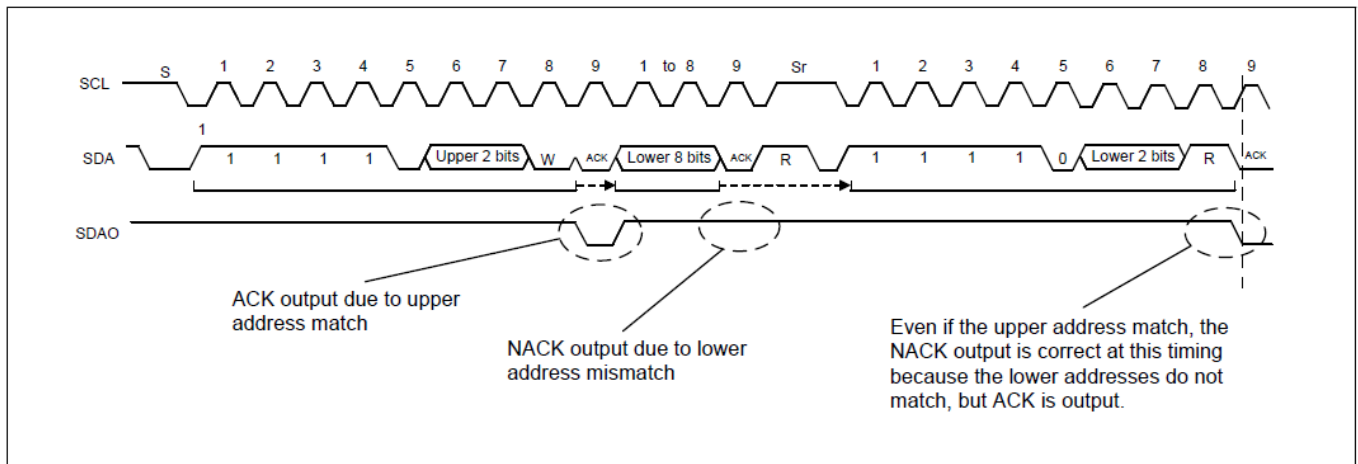
MCU Ver.1 has the following restrictions and workarounds. The restrictions and workarounds are not required for MCU Ver.2.

When multiple I²C slaves are connected to the I²C bus and there is a possibility that an I²C Slave other than this module will NACK for the upper address / R after Repeated START, there are the following restrictions and workarounds.

- Work around : Set the upper 2 bits of the 10-bit address assigned to this module to a value different from other Slave. If the address is exhausted and cannot be set to a different value, use restriction (1).
- Restriction (1) : 10-bit address not available.
- Restriction (2) : After the ACK response in the red circle in the above figure, none of the slaves respond to data, so the SDA keeps the high level and the I²C Master receives the 0xFF data. In the case of a system that can handle 0xFF as abnormal data, 0xFF is read and discarded on the I²C Master side. If 0xFF is valid data, use restriction (1).

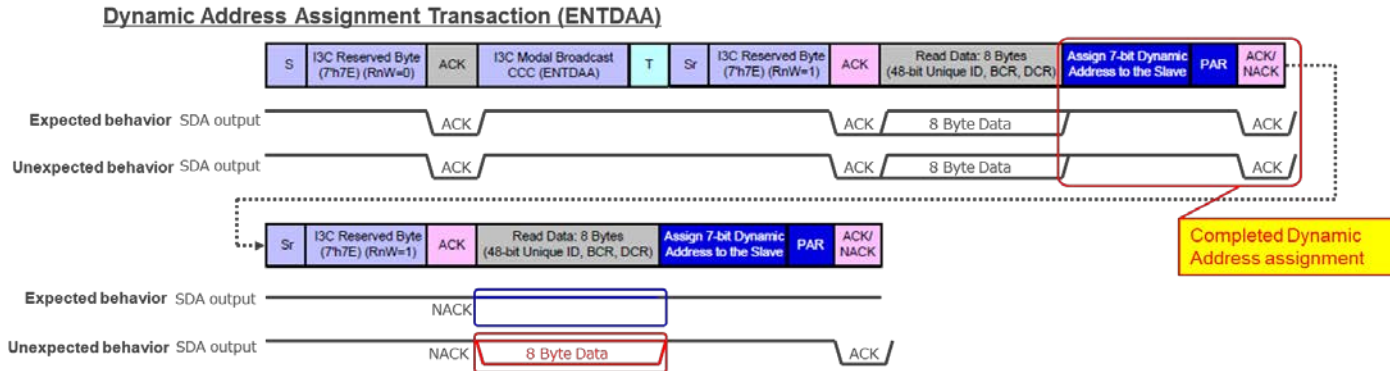
4 : I3C slave; Arbitration operation when Dynamic Address is assigned by the ENTDAAC command

In MCU Ver.1, if a dynamic address is assigned by the ENTDAAC command in I3C slave mode, I3C will participate in dynamic address arbitration in response to the ACK response of other slaves even after the dynamic address assignment.

MCU Ver.1 requires the restrictions and workarounds when assigning dynamic address, but the restrictions and workarounds are not required for MCU Ver.2.

1. Set the SDCTPIDH and SDCTPIDL registers (6 Bytes) of the I3C (I3C Slave) to a value (All 1 etc.) that has a lower priority than other Slave Devices by Dynamic Address Arbitration.
2. After setting the Static Address in the I3C (I3C Slave), assign the Dynamic Address using the SETDASA /SETAASA command.
3. Assign a Dynamic Address to an I3C Slave Device other than the I3C (I3C Slave) using the ENTDAAC command.

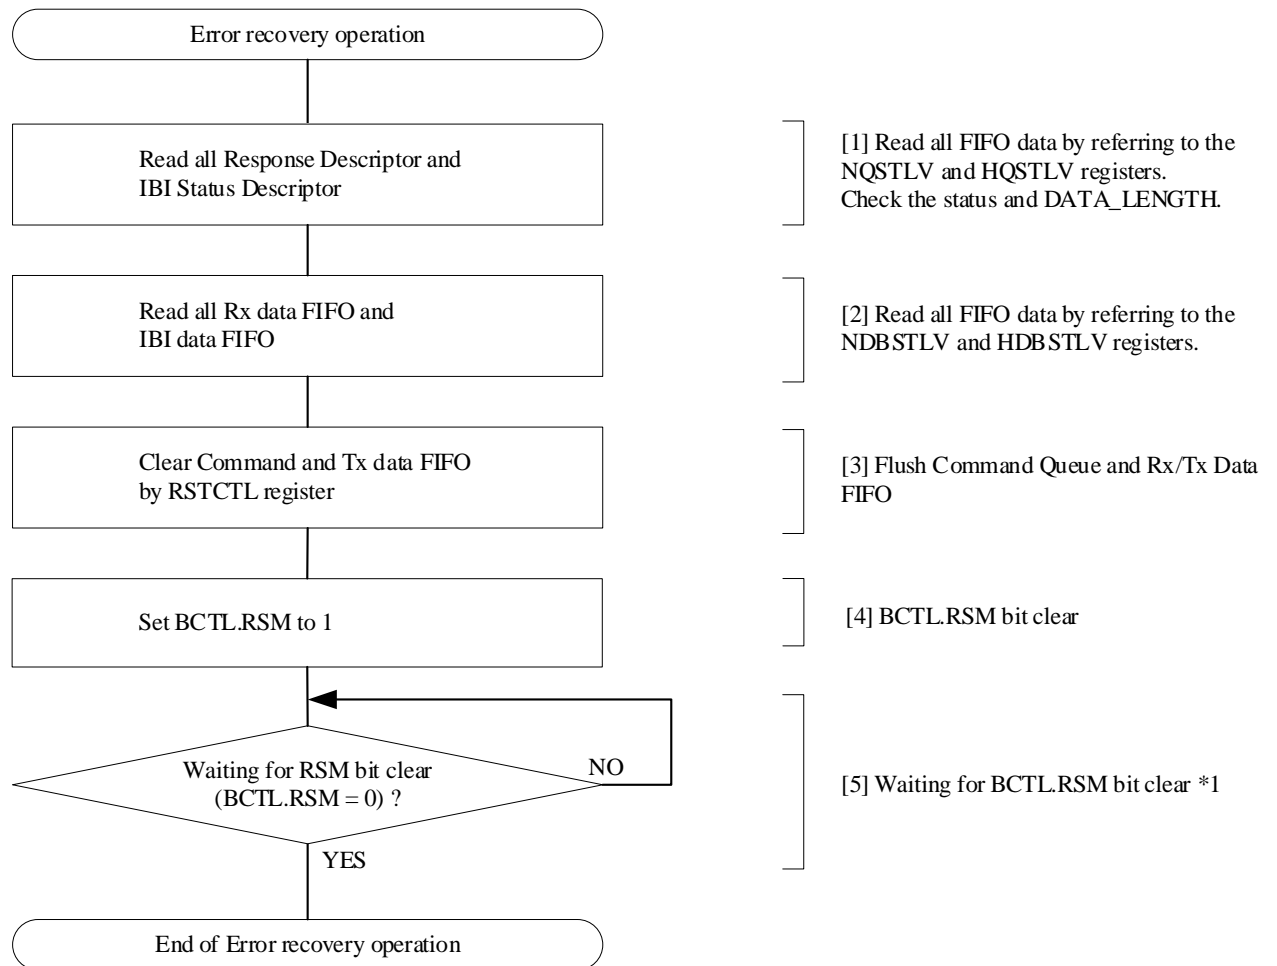
Figure 25.96-2 Example of error recovery operation flowchart for I3C Master

If an error occurs, I3C will be suspended. (BCTL.RSM becomes 1.) After I3C is suspended, the application must write the value 1 to the BCTL.RSM bit to resume I3C operation and recover from the suspended state.

Note 1. It is possible to set the Command Descriptor while waiting for the RSM bit to be cleared.
