Corrective Action to address FOX defects / DELPHI

**Minor Change: Layout Change to Mitigate Risk from
Defects in Bond Pads.**

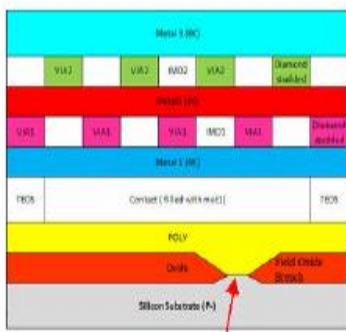
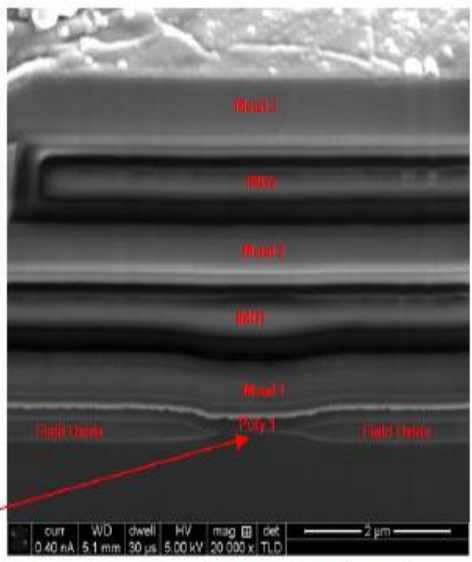
Bond Pad Defect

FIB X section & Sem of anomaly under pad

DELPHI/FA125020

Modify Masks to increase TOX in Defect Location.

- This involves a single mask change.
- The change would apply to the area under the bond pad only .
- No changes to the circuit operation → a low risk change.
- The change would increase the normal oxide thickness under the bond pad from ~2800ang to ~3700ang.
- This change would increase the oxide thickness in the extra active defect site to ~820 ang.
- This oxide breakdown would be > 70 v and would not wear-out with 30v applied.

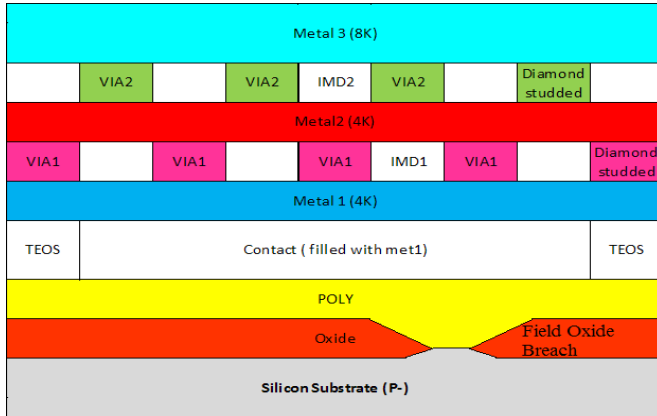
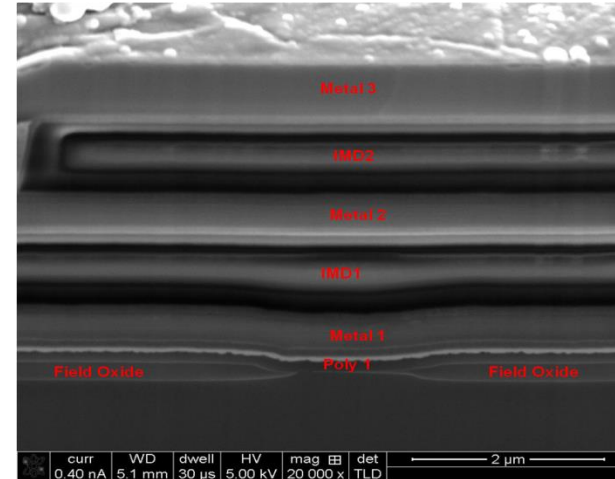
FOX Defect Formation

If a particle lands on the nitride it can block the removal of the layer. This leaves a small piece of nitride in an area which should be clear

Bond pad defect in this area

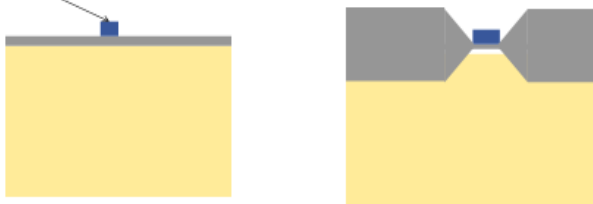
Defect at this stage would lead to the bond pad defect shown previously

Field oxidation has a very specific sloped profile down to the gate region

Wafers then undergo multiple oxide growths and strip stages which remove both the nitride defect and the oxide under it and grow instead a thin oxide of 135 ang in this region.

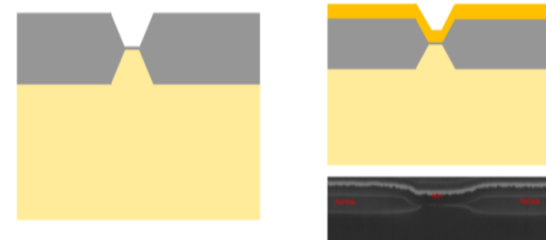
Thin oxide grows in defect region

Poly deposition creates a thin oxide capacitor.

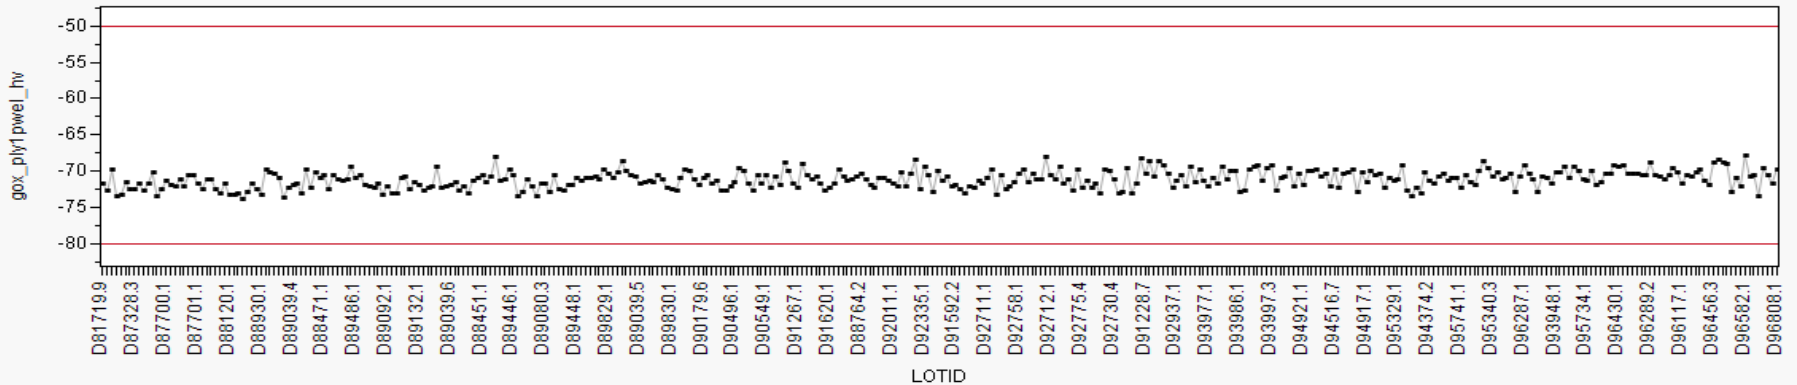
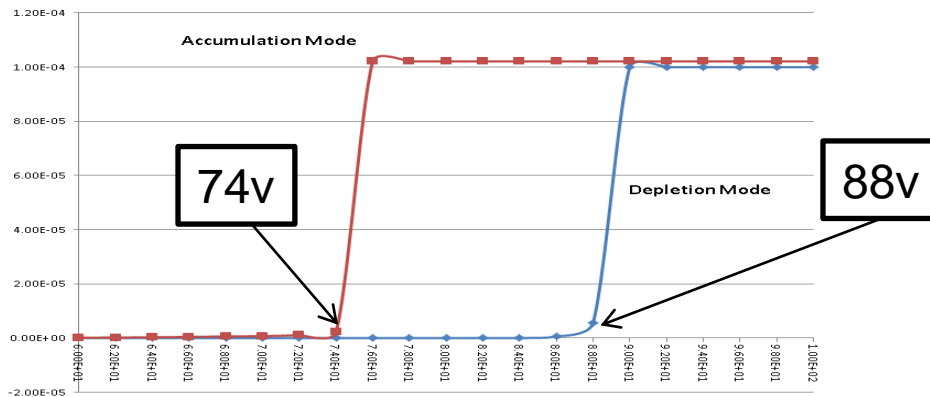
HV Gate Oxide End Of Line

- ◆ HV Gate Oxide is monitored at end of line using multiple structures
- ◆ HV Gox over PWEL trend shown below as measured in accumulation(-ve potential on the Poly) is > 70v will be higher again ~88v in depletion mode (+ve potential on the Poly).
