1 Products affected

2 Type of change

Ground terminal assembled with a clamping plate.

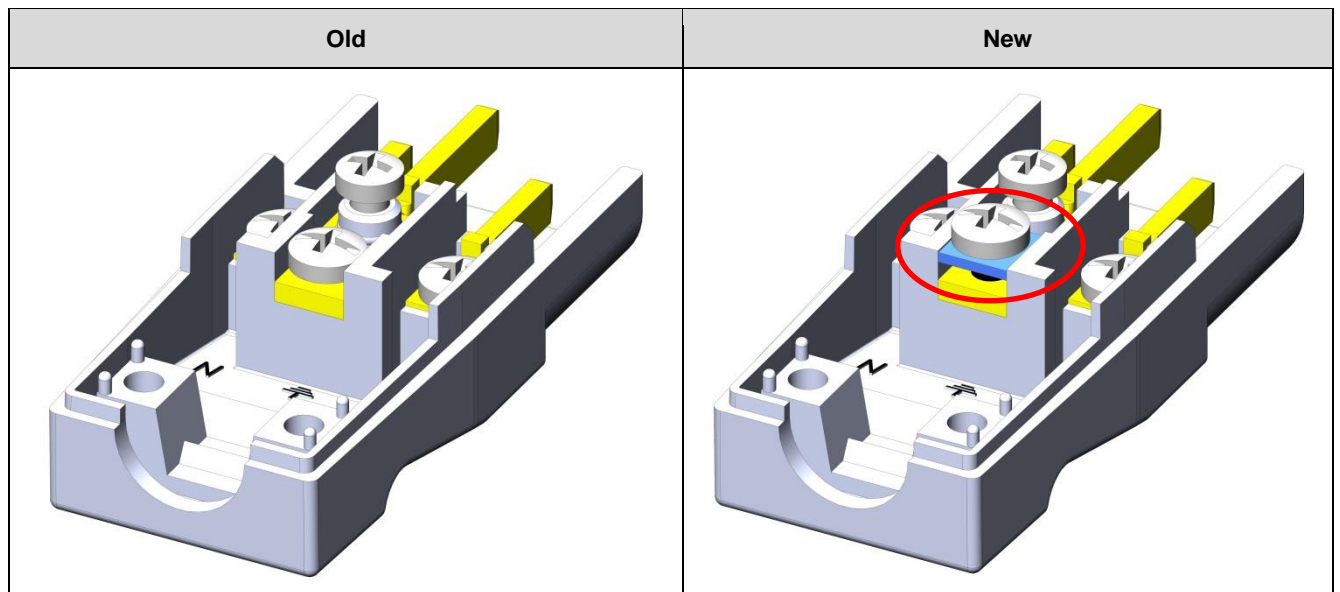
The terminal screw "Ground" is pre-assembled with a clamping plate, which will retain all individual wires below the screw head (blue part in picture below).

An uncareful wire insertion could lead to unsatisfactory screw connection. The clamping plate makes the handling easier and the screw connection more safe.
