# PRODUCT/PROCESS CHANGE NOTIFICATION

PCN APG/07/2403  
Notification Date 03/30/2007

**LQFP 7x7x1.4: NEW LEADFREE BOM QUALIFICATION**

## **RELIABILITY EVALUATION REPORT**

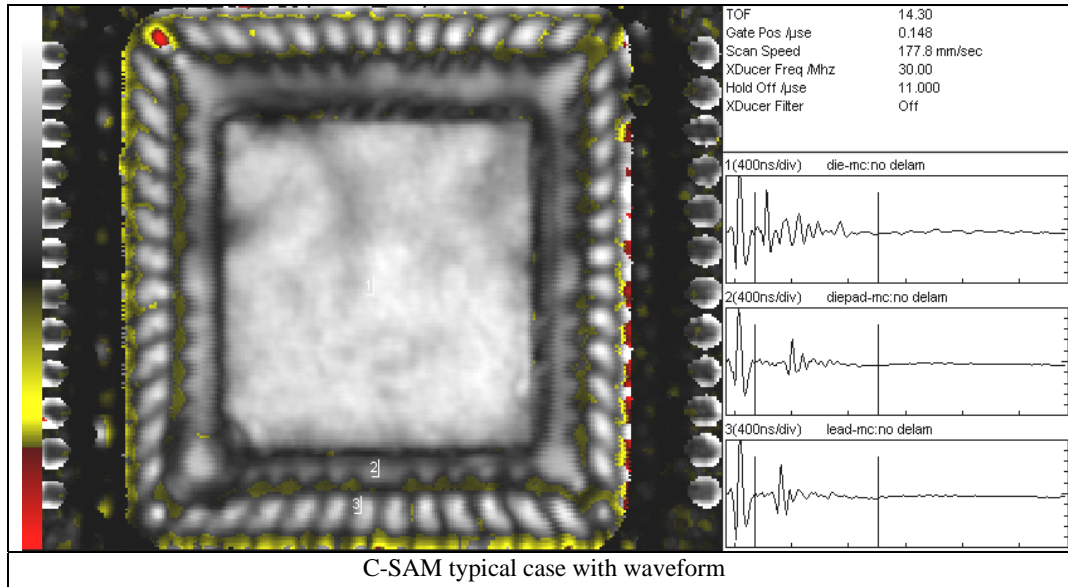
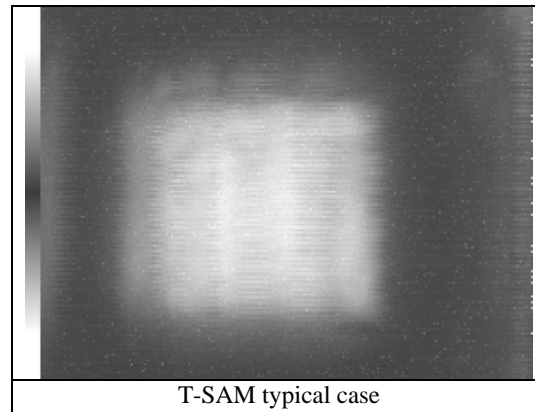
TECHNICAL CODE	PACKAGE	ANALYSIS ITEM	STRESS TEST
A55B*V341CAG	LQFP 48 7x7x1.4	SAM inspection	Unstressed

TEST EQUIPMENT: SONOSCAN D9000 (Scanning Acoustic Microscope)

Lot	Sample size	Defective parts (delamination)			
		die-mold (C-scan)	die-attach (T-scan)	I/f-mold (C-scan)	diepad-mold (C-scan)
996230H0	20	0/20	0/20	0/20	0/20
Transducer frequency (MHz)		30	30	30	30

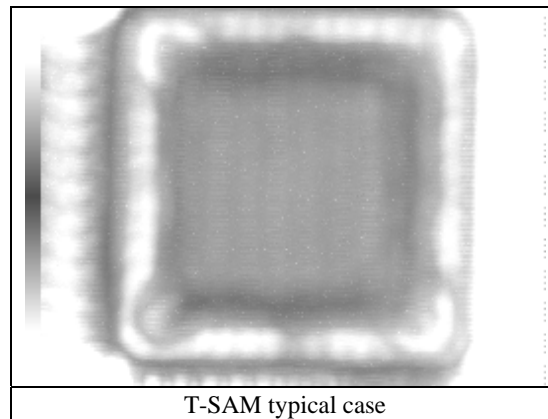
TECHNICAL CODE	PACKAGE	ANALYSIS ITEM	STRESS TEST
A55B*V341CAG	LQFP 48 7x7x1.4	SAM inspection	JL3 Preconditioning @260°C

TEST EQUIPMENT: SONOSCAN D9000 (Scanning Acoustic Microscope)

Lot	Sample size	Defective parts (delamination)			
		die-mold (C-scan)	die-attach (T-scan)	l/f-mold (C-scan)	diepad-mold (C-scan)
996230H0	20	0/20	0/20	0/20	20/20
Transducer frequency (MHz)		30	30	30	30

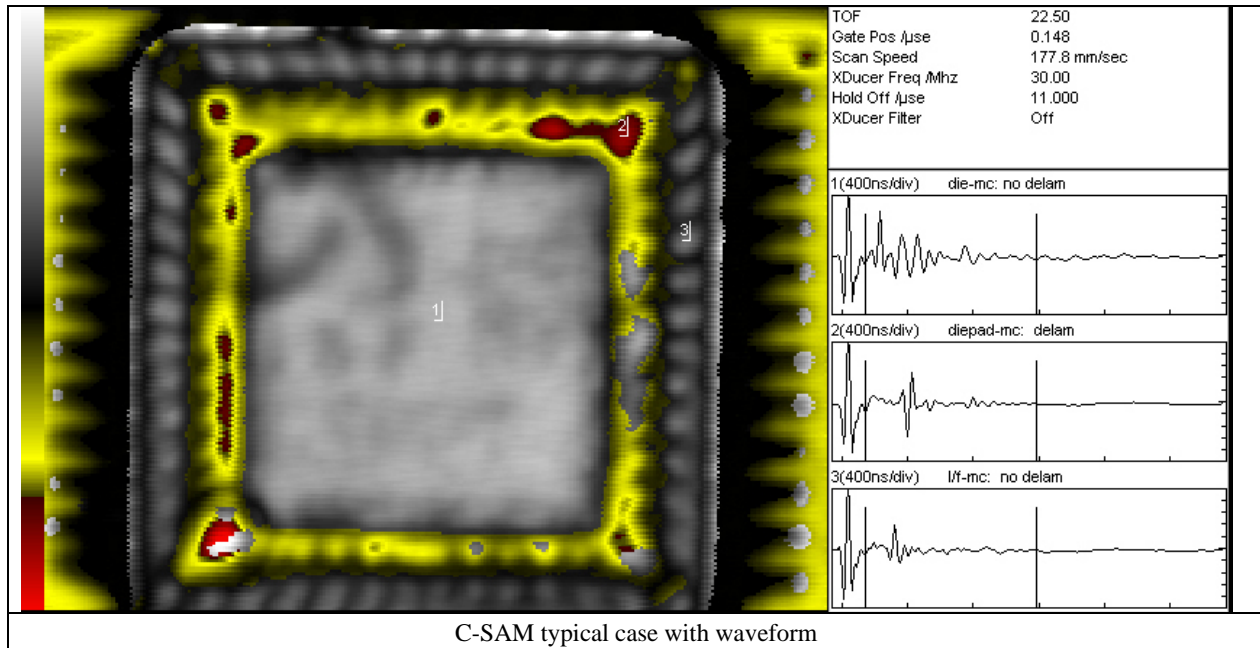
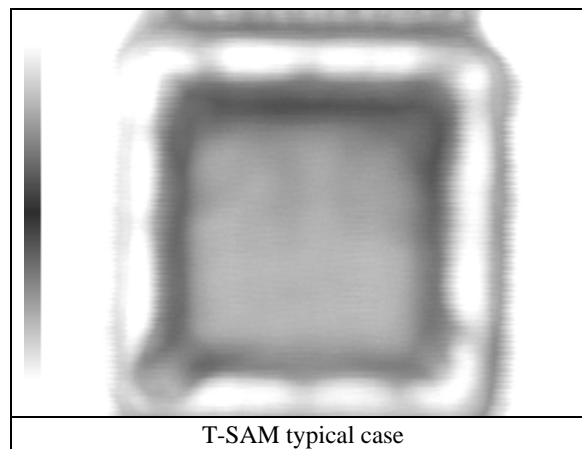
TECHNICAL CODE	PACKAGE	ANALYSIS ITEM	STRESS TEST
A55B*V341CAG	LQFP 48 7x7x1.4	SAM inspection	JL3@260°C + 1000 TC

TEST EQUIPMENT: SONOSCAN D9000 (Scanning Acoustic Microscope)

Lot	Sample size	Defective parts (delamination)			
		die-mold (C-scan)	die-attach (T-scan)	I/f-mold (C-scan)	diepad-mold (C-scan)
996230H0	20	0/20	0/20	0/20	20/20
Transducer frequency (MHz)		30	30	30	30

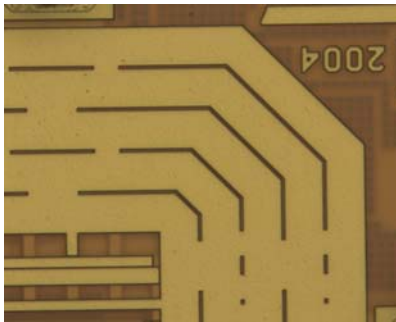
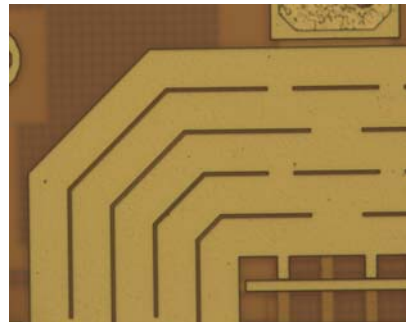
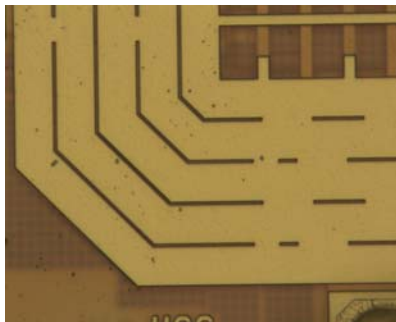
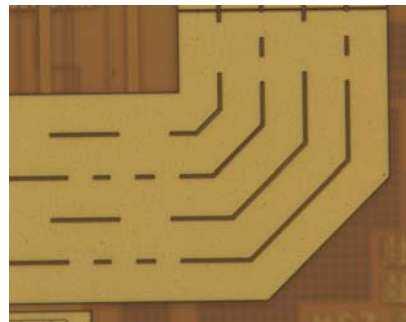
TECHNICAL CODE	PACKAGE	LOTS	ANALYSIS ITEM
A55B*V341CAG	LQFP 48 7x7x1.4	996230H0	Internal visual

WHAT	WHEN	SAMPLE SIZE /LOTS	RESULT
Passivation and metal	JL3+1000TC	5pcs	No significant defect (photo 1-4)

**TEST EQUIPMENT:** LEICA (Optical Microscope)

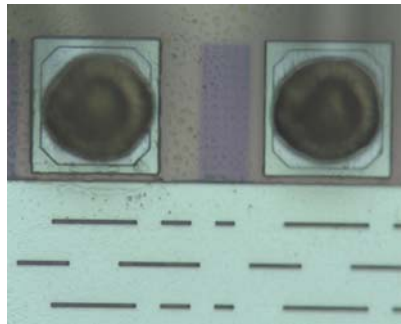
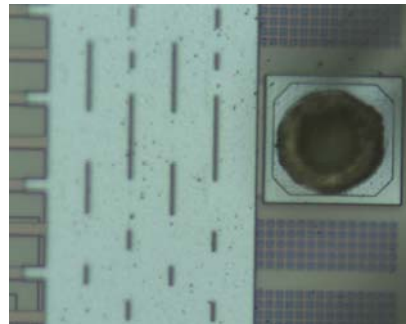
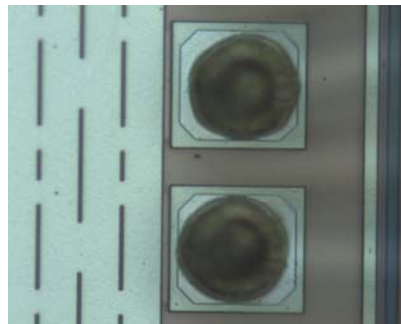
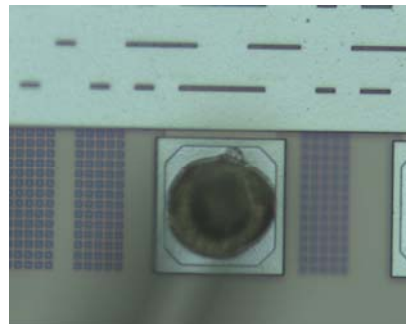
TECHNICAL CODE	PACKAGE	LOTS	ANALYSIS ITEM
A55B*V341CAG	LQFP 48 7x7x1.4	996230H0	Internal visual

WHAT	WHEN	SAMPLE SIZE /LOTS	RESULT
Metal corrosion and oxidation	JL3+168h PP	5pcs	No visible defect (photo 1-4)

**TEST EQUIPMENT:** LEICA (Optical Microscope)

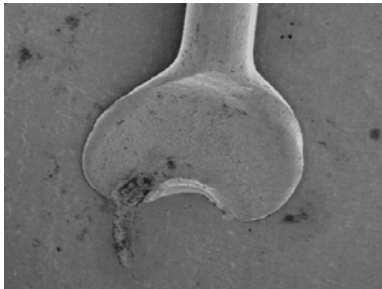
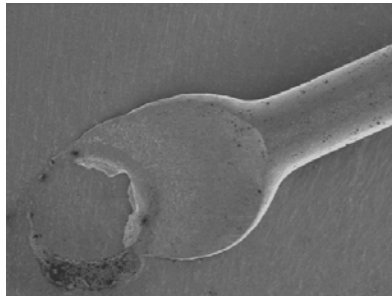
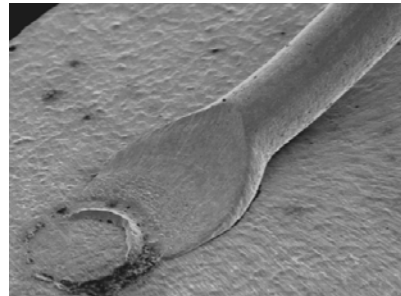
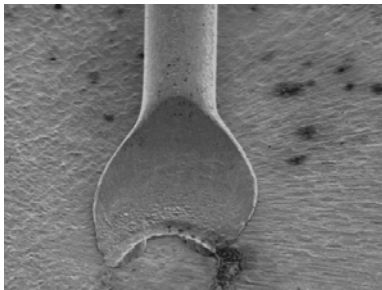
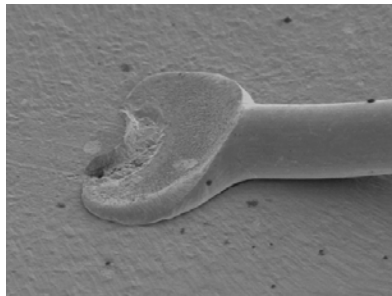
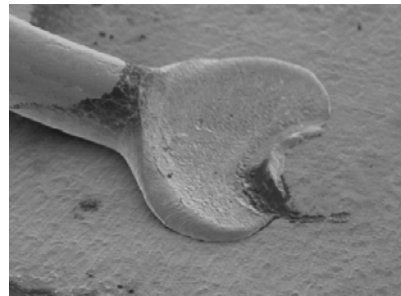
TECHNICAL CODE	PACKAGE	LOT	ANALYSIS ITEM
A55B*V341CAG	LQFP 48 7x7x1.4	996230H0	SEM inspection

WHAT	WHEN	SAMPLE SIZE	RESULT
Stitch-bond on lead	JL3+1000TC	5pcs/lot	No visible defect (photo 1-6)

**TEST EQUIPMENT:** HITACHI (Scanning Electron Microscope)

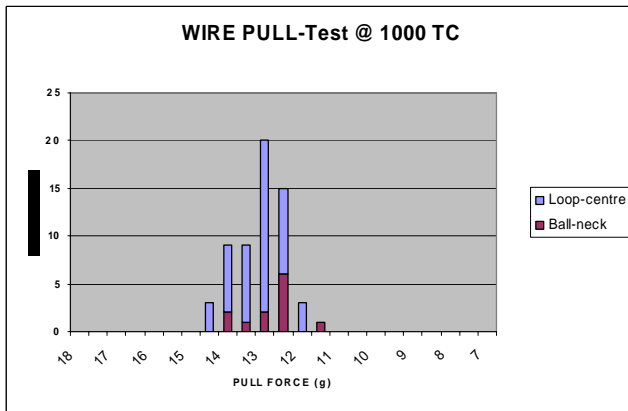
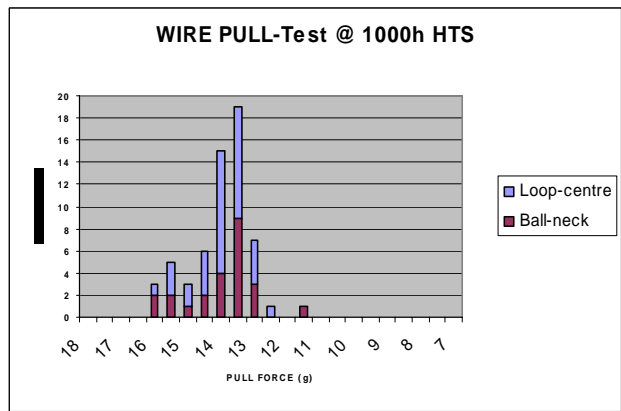
TECHNICAL CODE	PACKAGE	LOT	ANALYSIS ITEM
A55B*V341CAG	LQFP 48 7x7x1.4	996230H0	Wire pull-test

Wire type : Au, 1,2 mil  
 LSL (g) : 4,5

Failure mode		JL3+1000TC	1000h HTS 150°C
<b>2: BALL NECK</b>

mean (g)	12.61	13,68
	stdev (g)	0.67	1,04
	min (g)	11.33	11,04
	max (g)	13.82	15,75
	occurrence	20%	40%
<b>3: LOOP CENTRE</b>

mean (g)	12.91	13,79
	stdev (g)	0.65	0,78
	min (g)	11.72	12,43
	max (g)	14.40	15,76
	occurrence	80%	60%

**Remarks:** neither abnormal break loads, nor forbidden failure modes. AEC-Q100 criteria after TC passed.

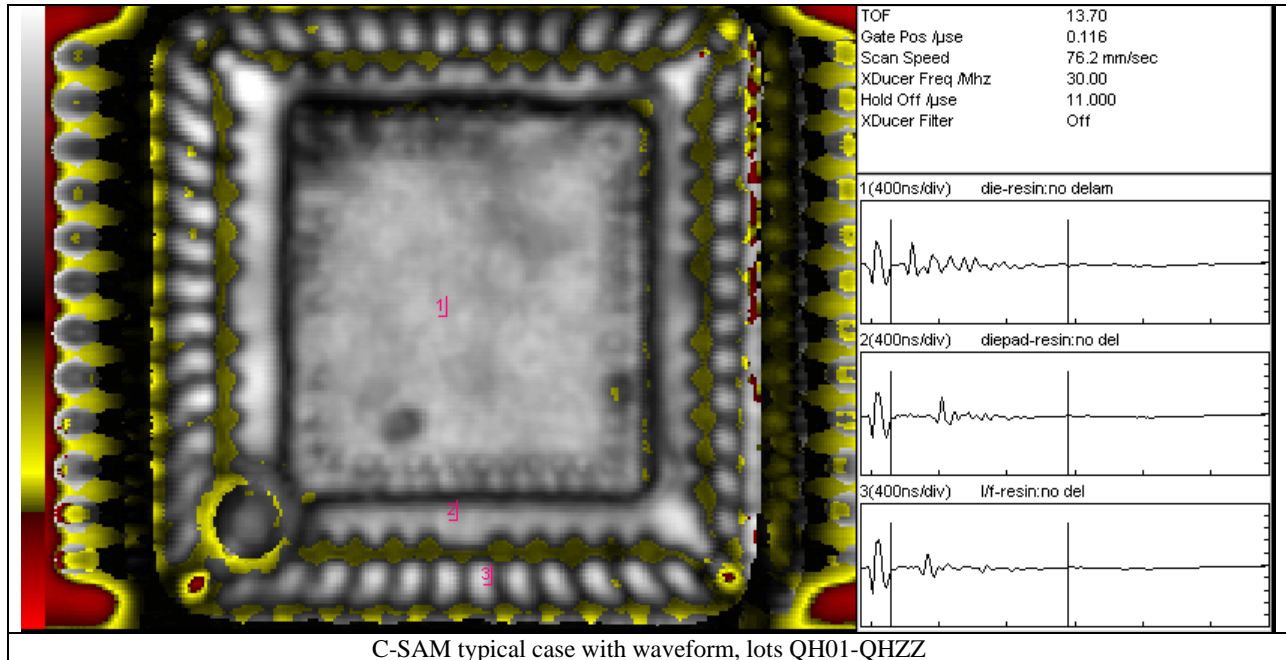
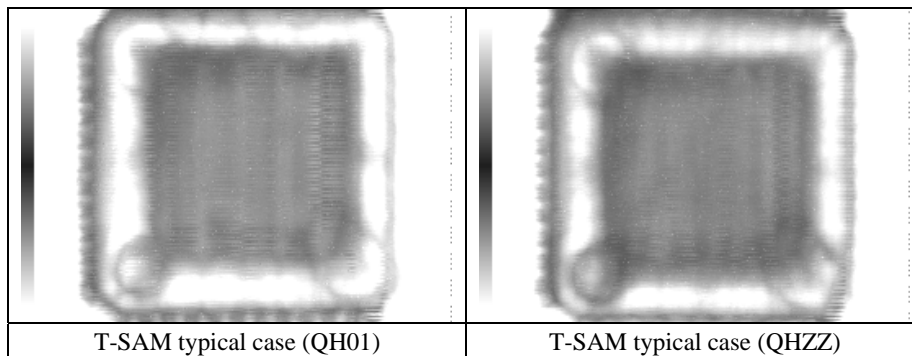
TECHNICAL CODE	PACKAGE	ANALYSIS ITEM	STRESS TEST
A55B*UR27BA6	LQFP 48 7x7x1.4	SAM inspection	Unstressed

TEST EQUIPMENT: SONOSCAN D9000 (Scanning Acoustic Microscope)

Lot	Sample size	Defective parts (delamination)			
		die-mold (C-scan)	die-attach (T-scan)	l/f-mold (C-scan)	diepad-mold (C-scan)
QH01	10	0/10	0/10	0/10	0/10
QHZZ	10	0/10	0/10	0/10	0/10
Transducer frequency (Hz)		30	30	30	30

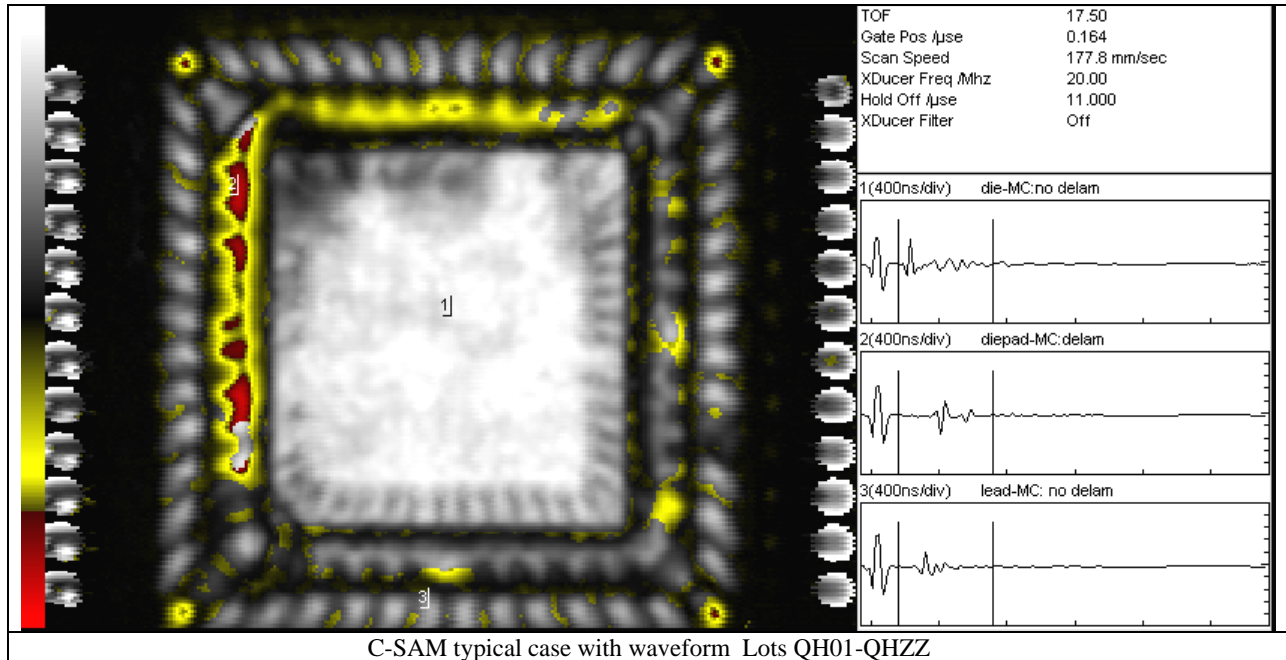
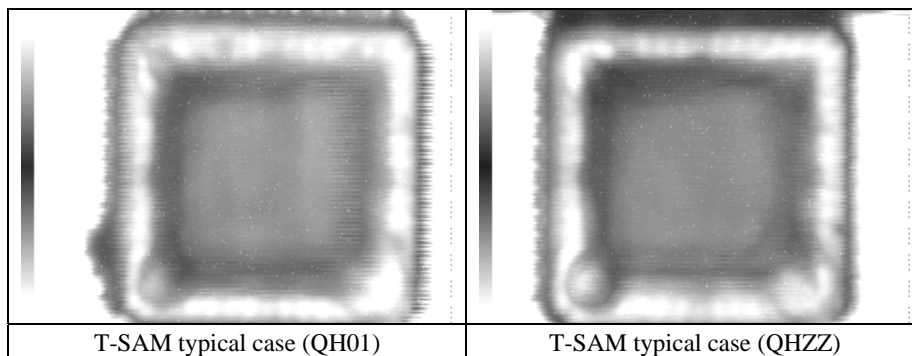
TECHNICAL CODE	PACKAGE	ANALYSIS ITEM	STRESS TEST
A55B*UR27BA6	LQFP 48 7x7x1.4	SAM inspection	JL3 Preconditioning @260°C

TEST EQUIPMENT: SONOSCAN D9000 (Scanning Acoustic Microscope)

Lot	Sample size	Defective parts (delamination)			
		die-mold (C-scan)	die-attach (T-scan)	l/f-mold (C-scan)	diepad-mold (C-scan)
QH01	10	0/10	0/10	0/10	10/10
QHZZ	10	0/10	0/10	0/10	10/10
Transducer frequency (Hz)		20	20	20	20

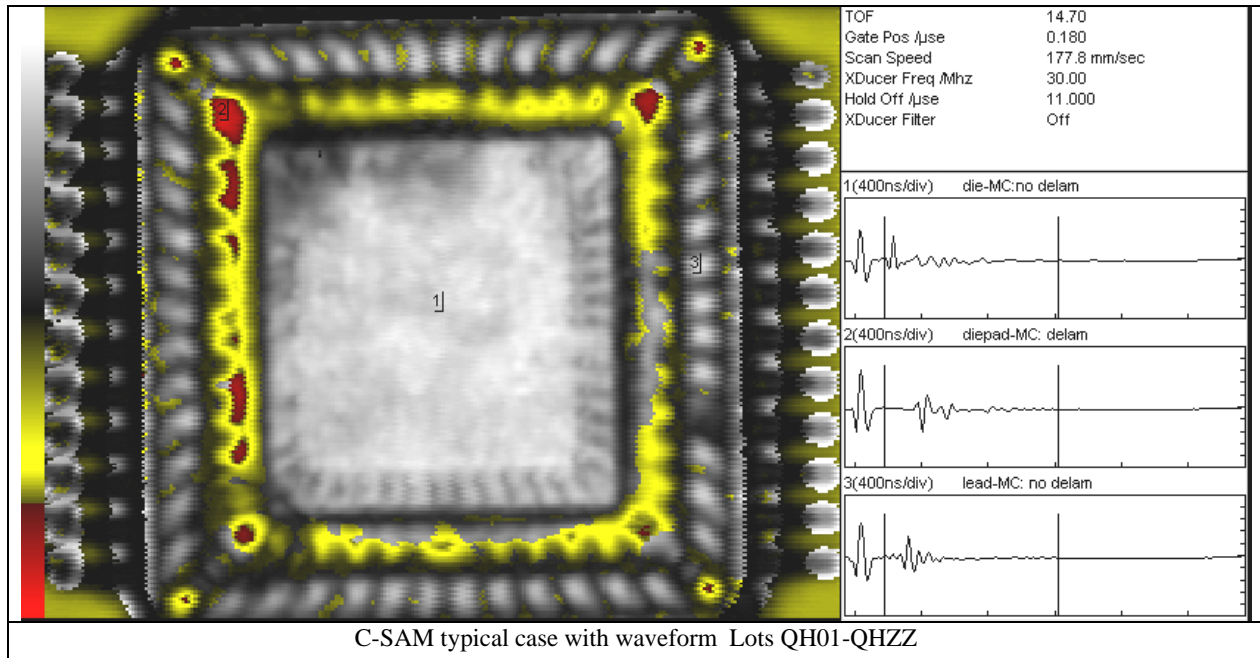
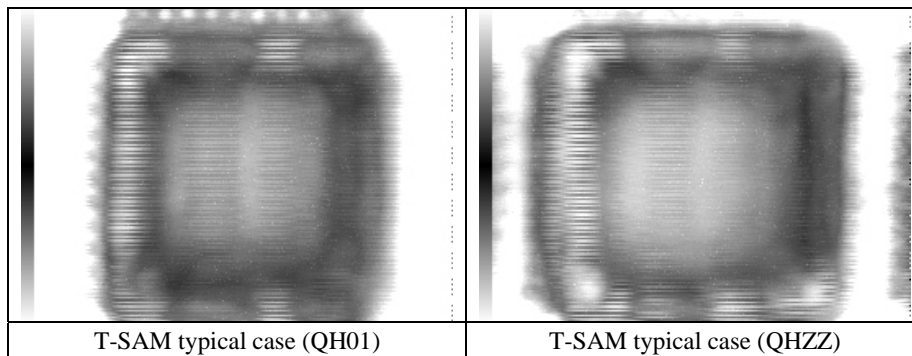
TECHNICAL CODE	PACKAGE	ANALYSIS ITEM	STRESS TEST
A55B*UR27BA6	LQFP 48 7x7x1.4	SAM inspection	JL3 +1000 TC (-50/+150°C)

TEST EQUIPMENT: SONOSCAN D9000 (Scanning Acoustic Microscope)

Lot	Sample size	Defective parts (delamination)			
		die-mold (C-scan)	die-attach (T-scan)	l/f-mold (C-scan)	diepad-mold (C-scan)
QH01	10	0/10	0/10	0/10	10/10
QHZZ	10	0/10	0/10	0/10	10/10
Transducer frequency (Hz)		30	30	30	30

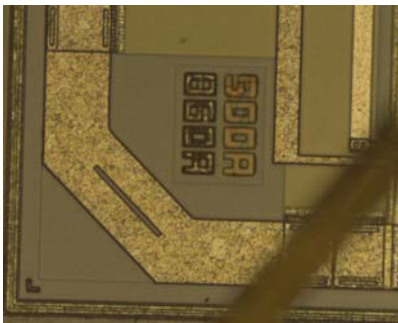
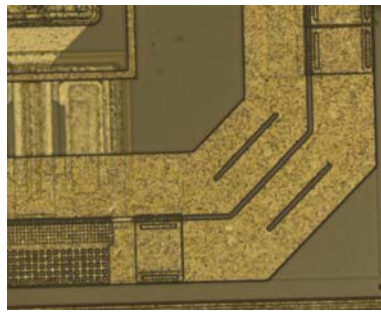
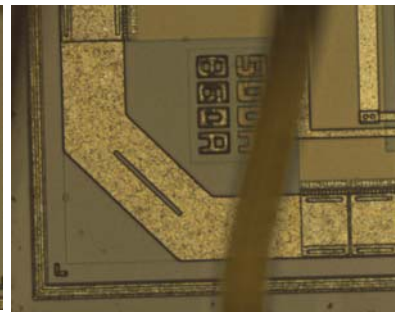
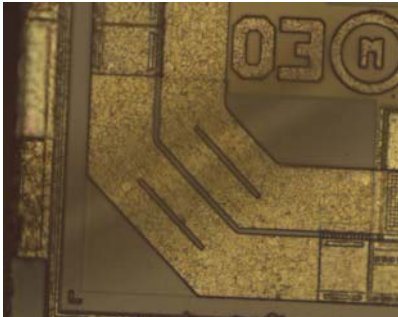
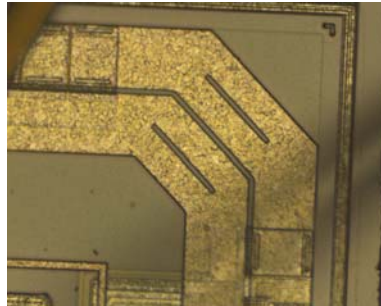
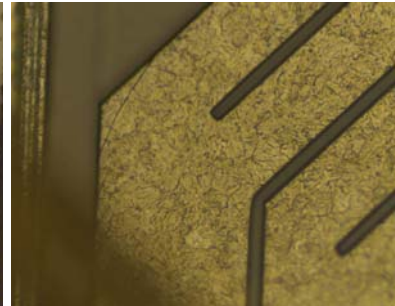
TECHNICAL CODE	PACKAGE	LOTS	ANALYSIS ITEM
A55B*UR27BA6	LQFP 48 7x7x1.4	996211QHZZ / 996211QH01	Internal visual

WHAT	WHEN	SAMPLE SIZE /LOTS	RESULT
Passivation and metal	JL3+1000TC	5pcs-QH01	Minor passivation cracks / no metal displacement (photo1-3)
Passivation and metal	JL3+1000TC	5pcs-QHZZ	Minor passivation cracks / no metal displacement (photo 4-6)

**TEST EQUIPMENT:** LEICA (Optical Microscope)

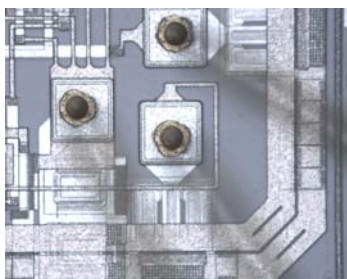
Photo 1 (10X)

WHAT	WHEN	SAMPLE SIZE /LOTS	RESULT
Metal corrosion and oxidation	JL3+168h PP	5pcs-QH01	No major defect (photo 1-3)
Metal corrosion and oxidation	JL3+168h PP	5pcs-QHZZ	No major defect (photo 4-6)

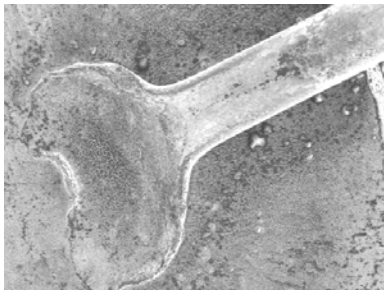
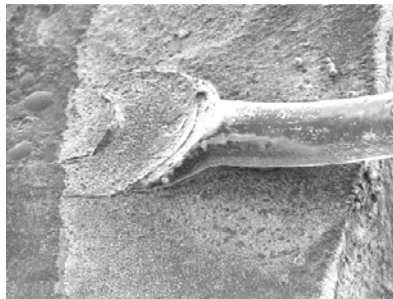
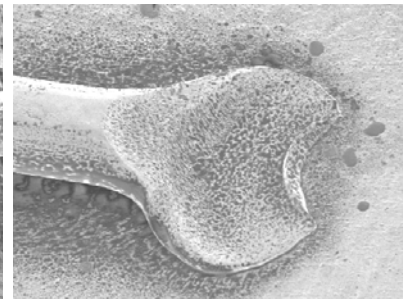
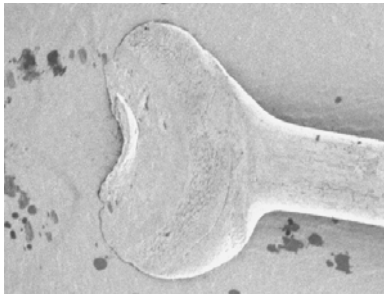
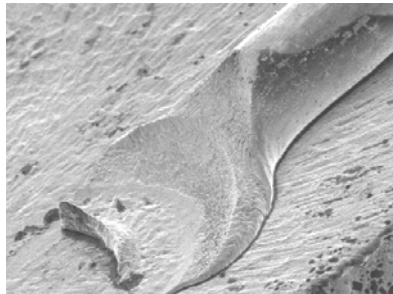
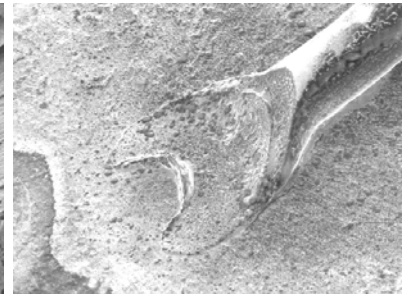
WHAT	WHEN	SAMPLE SIZE	RESULT
Stitch-bond on lead	JL3+1000TC	5pcs-QH01	No visible degradation (photo 1-3)
Stitch-bond on lead	JL3+1000TC	5pcs-QHZZ	No visible degradation (photo 4-6)

**TEST EQUIPMENT:** HITACHI (Scanning Electron Microscope)

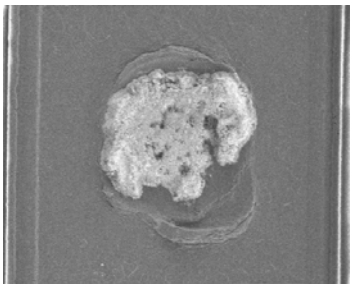
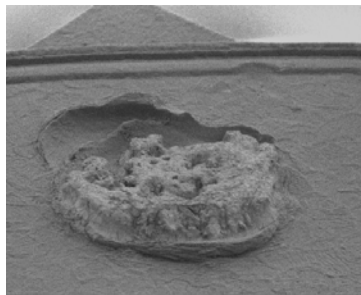
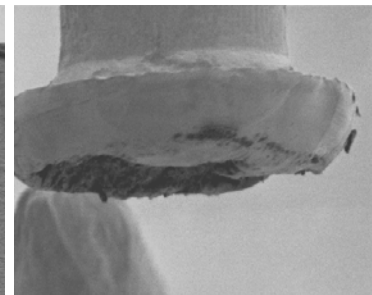
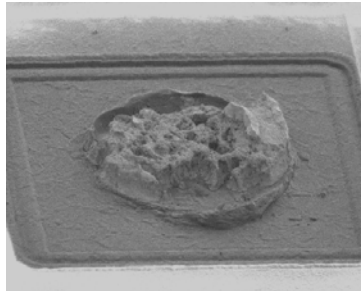
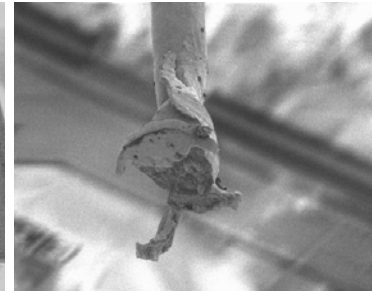
TECHNICAL CODE	PACKAGE	LOT	ANALYSIS ITEM
A55B*UR27BA6	LQFP 48 7x7x1.4	996211QHZZ	SEM inspection after wire pull-test

WHAT	WHEN	LOT	RESULT
Lifted bond after wire pull	1000h HTS	QHZZ	Intermetallic failure (photo 1-6)

The expected dominant wear-out mechanisms have been investigated by continuing THB and HTS tests until 2000h, and performing destructive physical analysis of long-term stressed devices. Wire-bonding performance has not been found to be in line with APG targets for long-term robustness, as the AuAl solder joint shows some degradation during HTS test leading to mechanical weakness (ball-lift mode at wire-pull test). This weakness has to be recovered through a wire-bonding process tuning as requested in CA-1-45-06-8240 by C. Douce, in order to optimize the ball shape and correctly fit the bond-pad opening.

- <sup>4</sup> Visual inspection after the stress has pointed out no significant corrosion / oxidation phenomena.
- <sup>5</sup> Wire-pull test after 1000 and 2000h has pointed out some weak ball-bonds, failing in ball lift mode with decreasing force (7.6g after 1000h and 2.6g after 2000h).

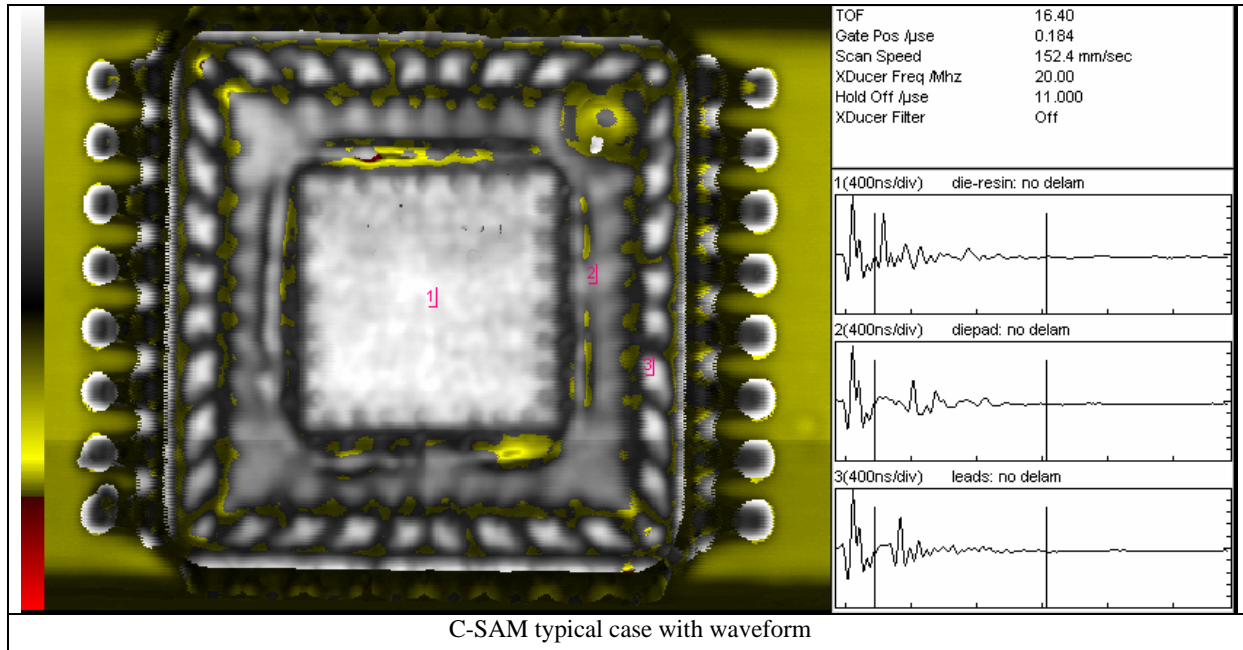
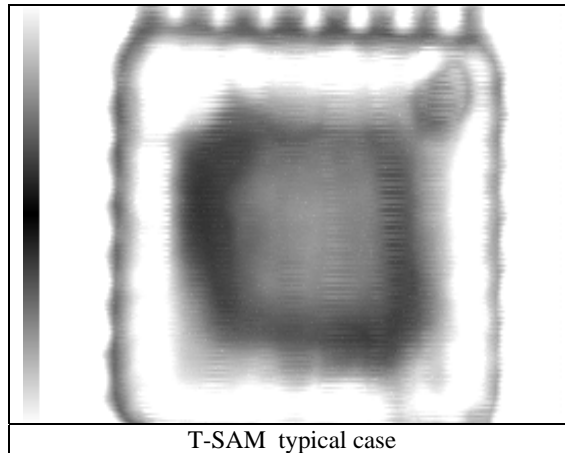
TECHNICAL CODE	PACKAGE	ANALYSIS ITEM	STRESS TEST
A55V*US10AA6	LQFP 32 7x7x1.4	SAM inspection	JL3 Preconditioning @260°C

TEST EQUIPMENT: SONOSCAN D9000 (Scanning Acoustic Microscope)

Lot	Sample size	Defective parts (delamination)			
		die-mold (C-scan)	die-attach (T-scan)	l/f-mold (C-scan)	diepad-mold (C-scan)
996021	10	0/10	0/10	10/10	0/10
Transducer frequency (MHz)		20	20	20	20

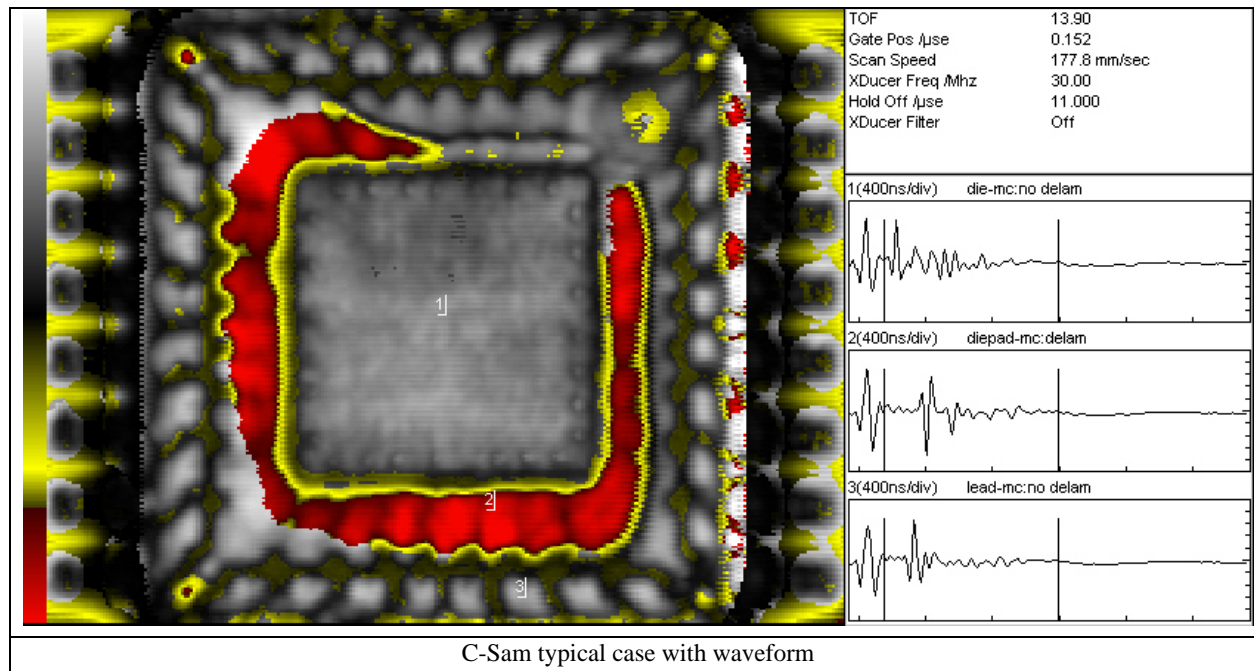
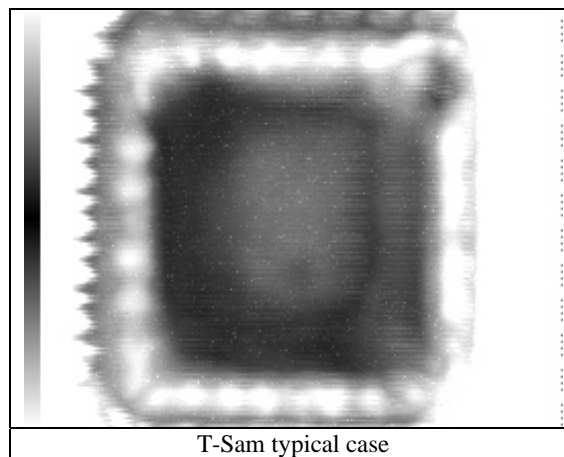
TECHNICAL CODE	PACKAGE	ANALYSIS ITEM	STRESS TEST
A55V*US10AA6	LQFP 32 7x7x1.4	SAM inspection	JL3+1000 TC (-50/+150°C)

TEST EQUIPMENT: SONOSCAN D9000 (Scanning Acoustic Microscope)

Lot	Sample size	Defective parts (delamination)			
		die-mold (C-scan)	die-attach (T-scan)	l/f-mold (C-scan)	diepad-mold (C-scan)
996021	10	0/10	0/10	0/10	10/10
Transducer frequency (MHz)		30	30	30	30

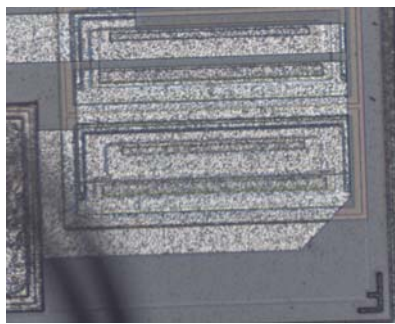
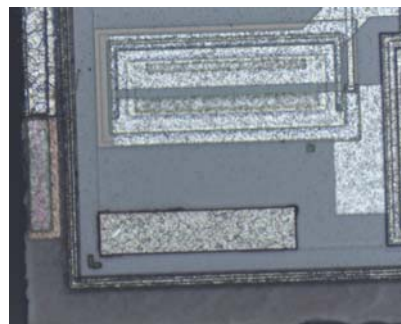
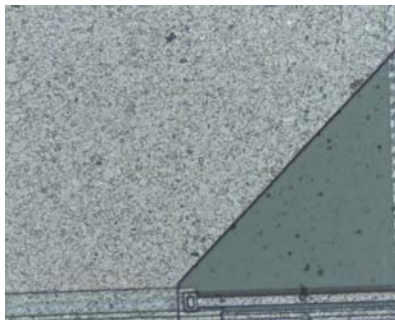
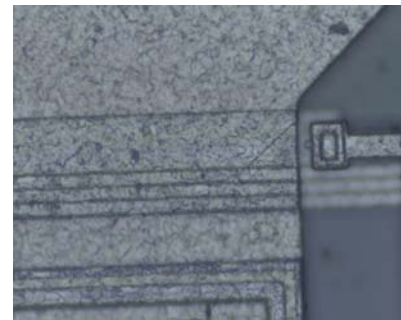
TECHNICAL CODE	PACKAGE	LOTS	ANALYSIS ITEM
A55V*US10AA6	LQFP 32 7x7x1.4	996021	Internal visual

WHAT	WHEN	SAMPLE SIZE	RESULT
Passivation and metal	JL3+1000TC (-50/+150°C)	5pcs	Minor passivation cracks / no metal displacement

**TEST EQUIPMENT:** LEICA DMRE (Optical Microscope)

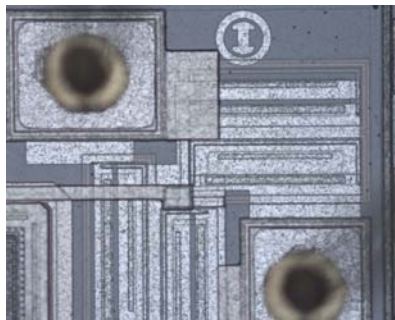
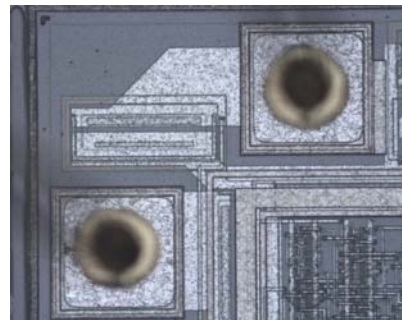
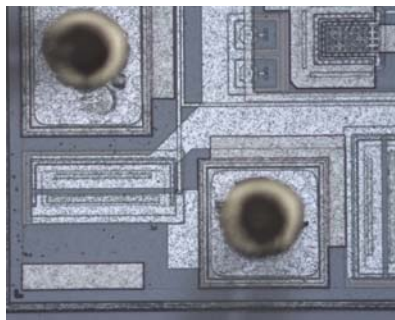
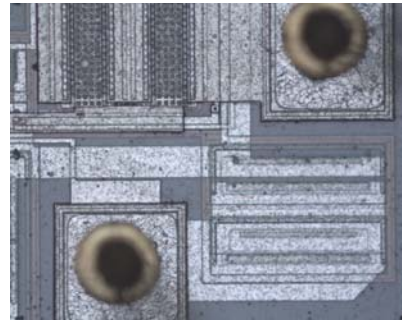
WHAT	WHEN	SAMPLE SIZE	RESULT
Metal corrosion and oxidation	JL3+ES	5pcs	No visible defect (photo 1-4)

**TEST EQUIPMENT:** LEICA DMRE (Optical Microscope)

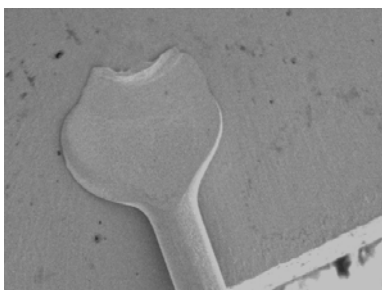
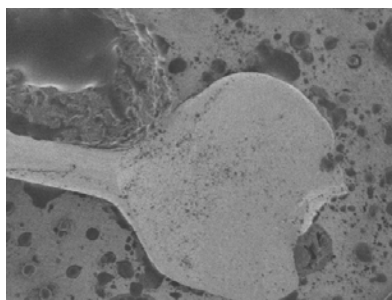
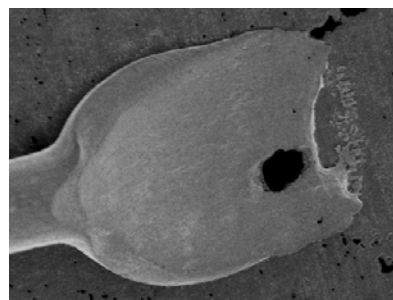
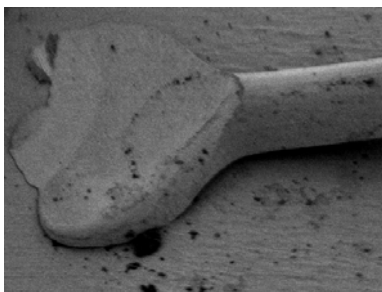
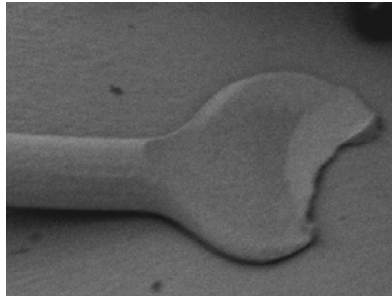
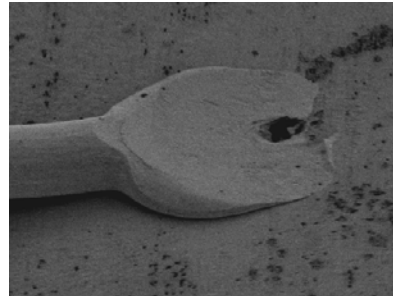
WHAT	WHEN	SAMPLE SIZE	RESULT
Stitch-bond on lead	JL3+1000TC (-50/+150°C)	5pcs	No visible defect (photo 1-6)

**TEST EQUIPMENT:** HITACHI S4500 (Scanning Electron Microscope)

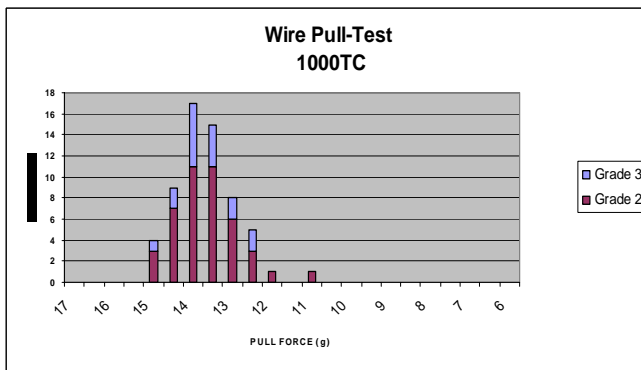
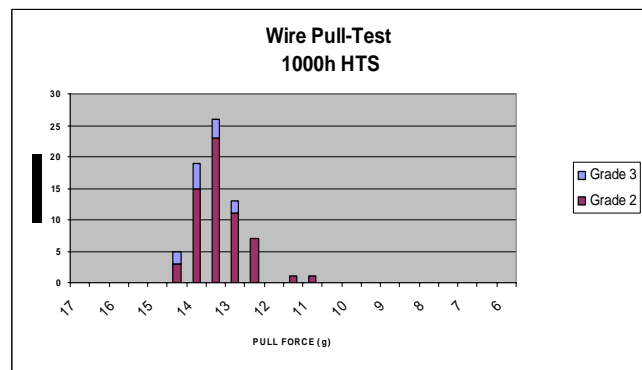
Failure mode		1000TC (-50/+150°C)	1000h HTS@150°C
<b>2: BALL NECK</b>

mean (g)	13,46	13,55
	stdev (g)	0,61	0,51
	min (g)	12,25	12,53
	max (g)	14,65	14,14
	occurrence	28%	15%

TEST EQUIPMENT: DAGE series 4000

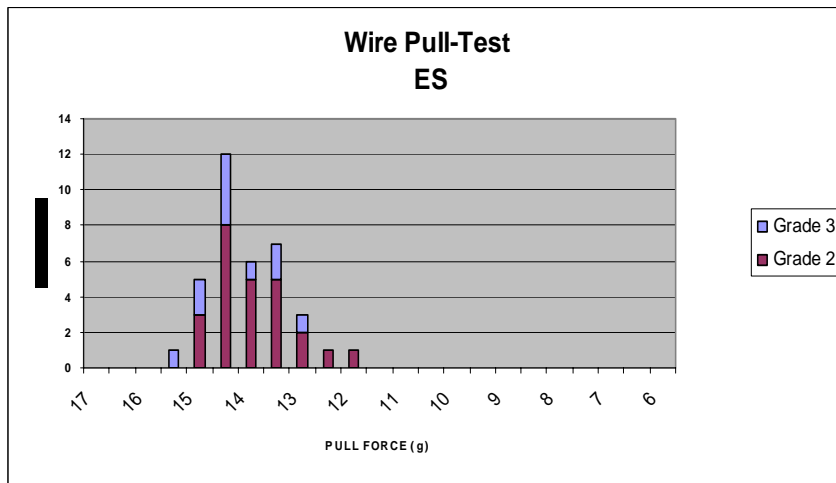
<b>TECHNICAL CODE</b> A55V*US10AA6	<b>PACKAGE</b> LQFP 32 7x7x1.4	<b>LOT</b> 996021	<b>ANALYSIS ITEM</b> Wire pull-test
---------------------------------------	-----------------------------------	----------------------	--

Failure mode	JL3+ES (100TC+96h PP)	
<b>2: BALL NECK</b>

mean (g)	14,00
	stdev (g)	0,74
	min (g)	12,77
	max (g)	15,07
	occurrence	30%

TEST EQUIPMENT: DAGE series 4000

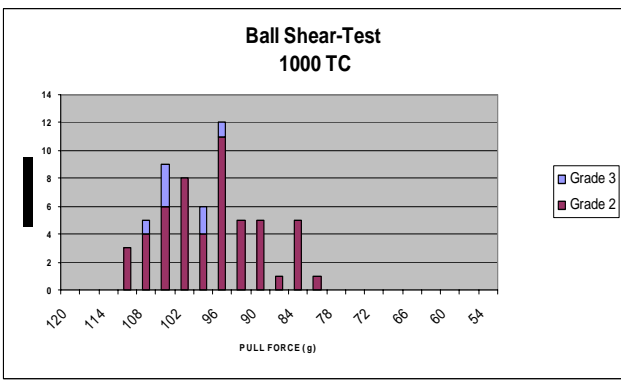
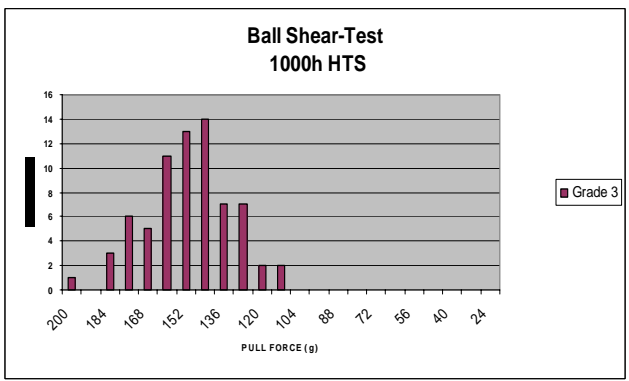
TECHNICAL CODE	PACKAGE	LOT	ANALYSIS ITEM
A55V*US10AA6	LQFP 32 7x7x1.4	996021	Ball-shear test

Failure mode		1000TC (-50/+150°C)	1000h HTS 150°C
<b>2: PAD SHEAR</b>

mean (g)	101,34	147,03
	stdev (g)	3,91	17,64
	min (g)	95,51	108,63
	max (g)	105,17	192,58
	occurrence	12%	100%

TEST EQUIPMENT: DAGE series 4000

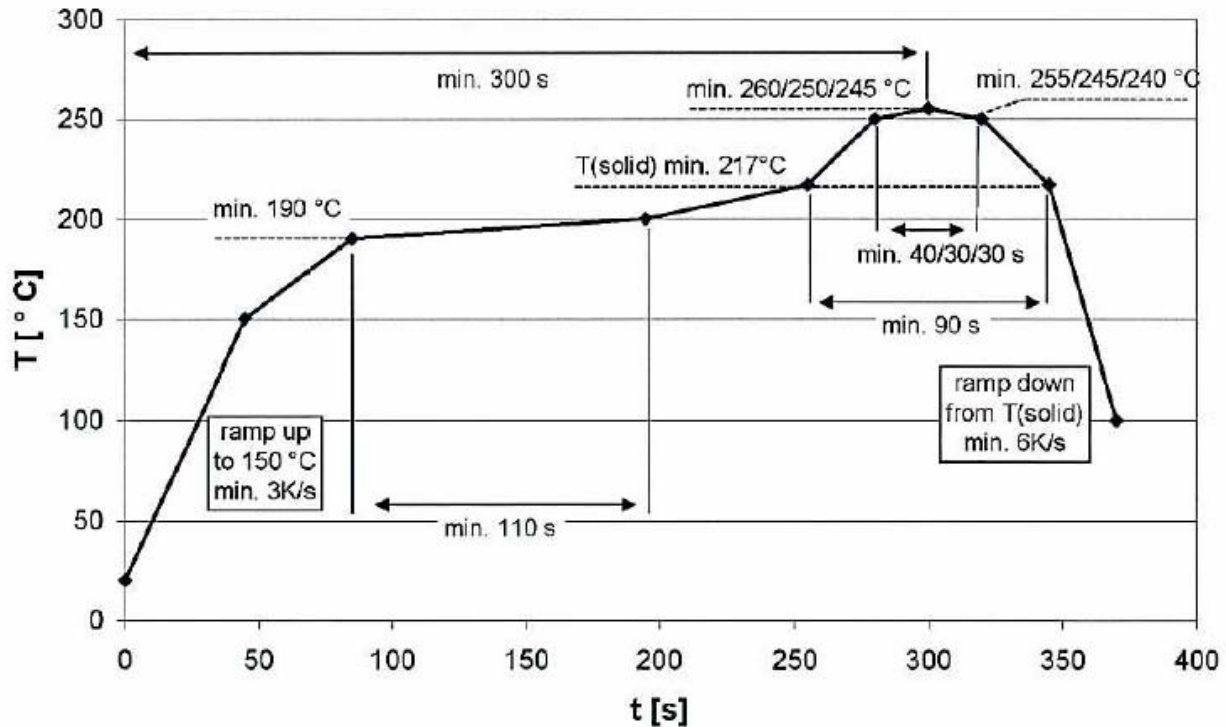
## ATTACHMENT 4: REFLOW PROFILE

Profile Features	Class1 (small)	Class 2 (large)	Class 3 (very large)
<b>preheat</b>			
ramp-up rate to 150 °C	min. 3 K/s (average value over 10 s)		
time from 190°C to 200°C	min. 110 s		
<b>peak</b>			
ramp-up rate from 200°C to $T_{peak}$	0,5 K/s - 3 K/s (average value over 10 s)		
time above $T_{solid,us}$ (min. 217 °C)	min. 90 s		
peak temperature $T_{peak}$	260 (- 0) °C	250 (- 0) °C	245 (- 0) °C
time above $T_{peak} - 5 K$	min. 40 s	min. 30 s	min. 30 s
<b>cooling</b>			
ramp-down rate: from $T_{solid,us}$ (min. 217 °C)	min. 6 K/s (average value over 10 s)		
<b>general</b>			
time 25 °C to $T_{peak}$	min. 300 s
