Corrective Action to address FOX defects / DELPHI

**Minor Change: Layout Change to Mitigate Risk from
Defects in Bond Pads.**

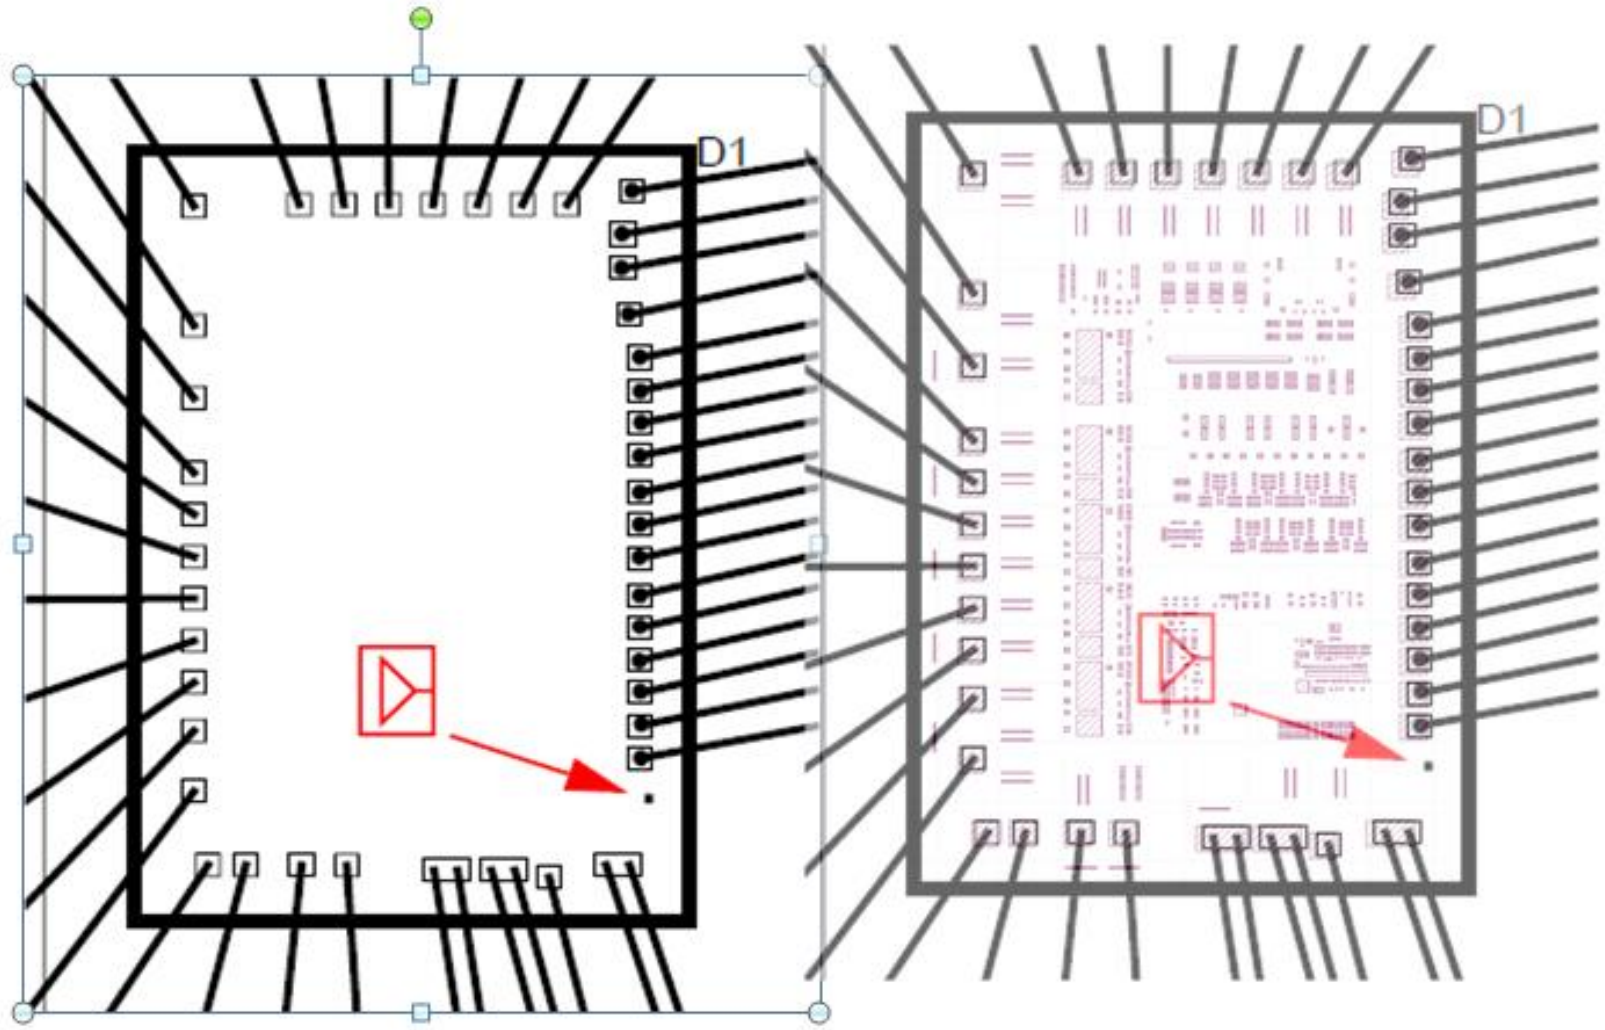
Bond diagram overlay

TGATE mask defines areas of thick gate oxide for high voltage devices on the process. The proposal involves changing this mask to include the bond pad areas without making any other in circuit changes.

- ◆ ADI addressing root cause of occurrence via defect mitigation, error proofing .
- ◆ This involves an ability to ensure that tox. in the defect area is > 800 ang. vs. 135 ang. minimum currently .
- ◆ The change would apply to area under the bond pad only.

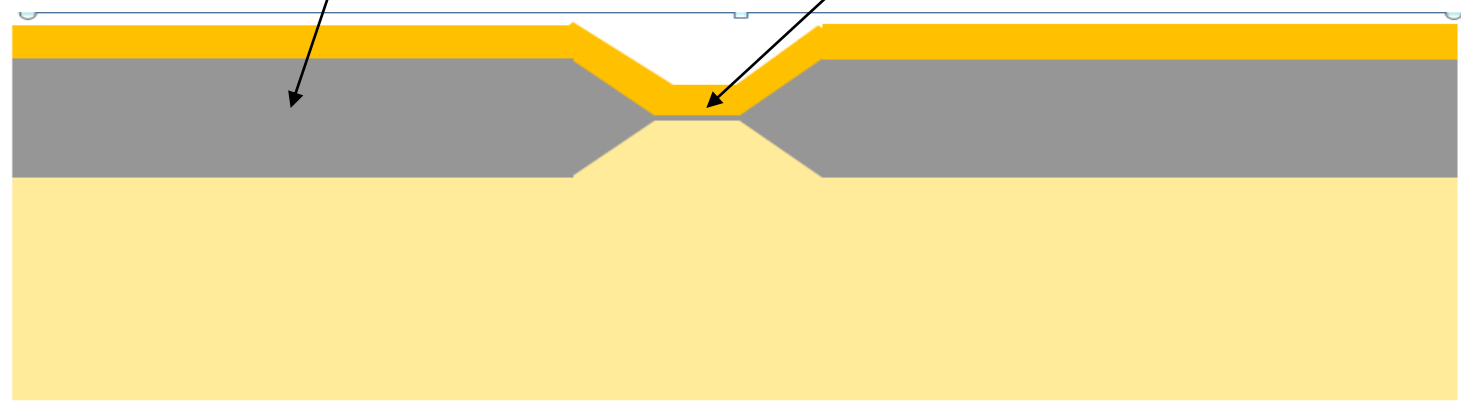
End of Line Field Oxide in bond pad region will thicken up to ~3700ang from ~2800

Defect Tox thickens up to ~820ang From ~135ang.
