## PRODUCT / PROCESS CHANGE INFORMATION

VL53L0CXV0DH/1 sensor modules contain a cap. To maintain the highest delivery standards for this high volume product family, and strengthen our supply chain, an additional cap supplier has been qualified.

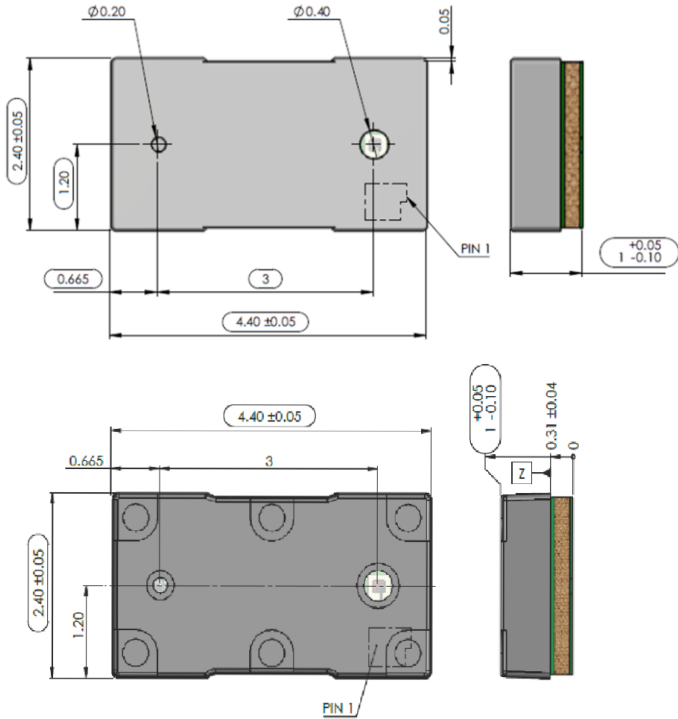
Cap from current supplier	Cap from additional supplier
<b>Appearance</b>

<b>Testing</b>	100% Caps tested at cap supplier, 100% modules tested at ST Shenzhen	No change. No change.
<b>Visual Inspection</b>	100% Caps inspected at cap supplier, Caps inspected by sampling at ST Shenzhen, 100% modules inspected at ST Shenzhen (Automatic Visual Inspection)	No change. No change. No change.
<b>Dimensions</b>

<b>Status</b>	Cap is fully qualified at cap supplier, including 1000h reliability	Qualified cap

The qualification of this change module level is being completed at ST Shenzhen. Detailed qualification plan and relevant documentation will be provided upon request.
